# ROOF ASSESSMENT REPORT

Roof Maxx of Wilmington, NC  
Wilmington, NC

| Inspection Date | August 17, 2026 |

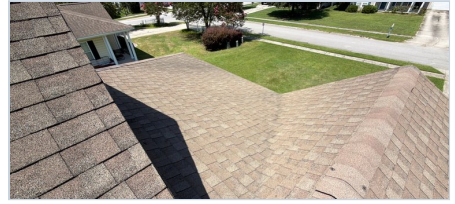
1. Front elevation. Architectural asphalt shingle across multiple planes.

2. Front roof planes above the garage. No missing tabs and the deck planes are straight.

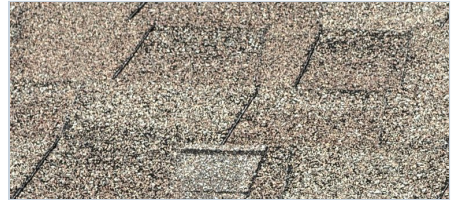
3. Roof overview from the ridge. Plane and valley layout across the front of the home.

4. Main hip ridge running the length of the roof.

5. Shingle field on an accessible plane. Dry surface with moderate localized granule loss.

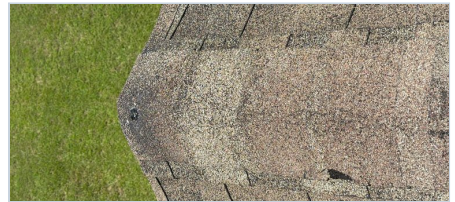
6. Close view of the shingle surface showing granule loss and wear across the field.

7. Ridge cap wear and color variation along the hip.

8. Damaged ridge cap shingle with exposed fasteners at the cap.

- Replace the two damaged ridge cap shingles
- Reset and seal the isolated nail pops and exposed fasteners across the accessible planes
- Install a rain collar at the plumbing penetration
- Hand seal lifted shingles and ridge caps, seal roof penetrations and vent collars
- Clear debris from the roof slopes
- Low pressure roof cleaning of the algae stained areas, completed before treatment
- Roof Maxx treatment on approximately 2,261 sq ft of asphalt shingle, applied once the surface is dry
- Final flexibility and condition check completed on the day of service before treatment
- Before and after photo documentation

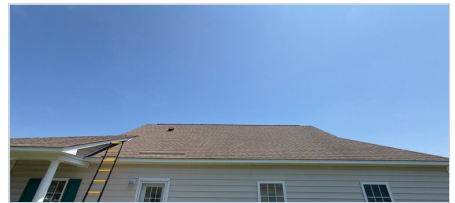
9. Second damaged ridge cap at the hip corner with an exposed fastener.

10. Plumbing penetration requiring a rain collar, with granule loss around the penetration.

11. Rear hip ridge and roof planes above the back of the home.

12. Rear elevation showing the roof planes and penetrations.
